CASE REPORT

ENDODONTIC STABILIZATION USING IMPLANTS WITH AN IMPROVED DESIGN - A REPORT OF 2 CASES

J Odontol Res 2013;1(1):93-8.

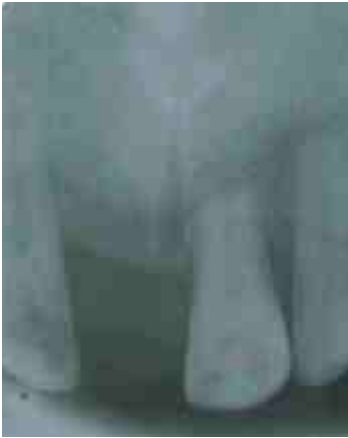
Figure 1. Pre operative radiograph of 21 showing apical root resorption.

The medical condition of the patient was essentially negative. The right maxillary central incisor 11 was found missing. The intra oral peri apical radiographs made at the initial visit revealed apical root resorption in the left maxillary central incisor 21. The root structure was resorbed to a level that only 7-8mm of the root was found within the bone (Fig 1). 21 tested non vital on electrical and thermal pulp testing (heated gutta percha) and the tooth exhibited Grade I mobility. The gingival status and the periodontal probing depth was found to be within normal limits for 21.

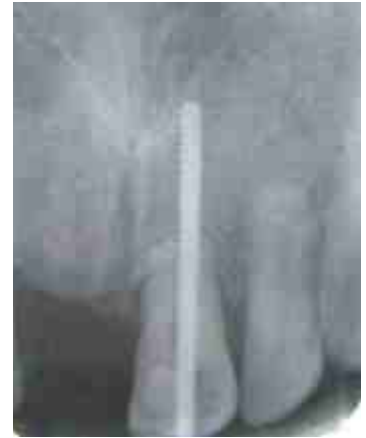
Figure 3. Immediate post operative radiograph.

The canal was thoroughly irrigated and dried with paper points, the intra osseous portion of the endodontic implant was marked and only the portion of the implant that would be inside the canal is coated with Type II glass ionomer cement and the implant was tapped back into place. The excess length of the stabilizer extending beyond the incisal edge was sheared off using a diamond disk while maintaining finger pressure to minimize vibration and the access sealed with glass ionomer cement. Figure 3 shows an immediate post operative radiograph.

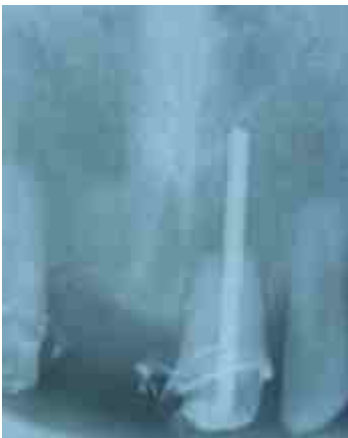
Figure 4. 1yr follow-up radiograph.

The patient experienced no post operative pain or swelling and healing was uneventful. He was scheduled for post operative evaluation at 1 month interval for 6 months. The follow up radiographs showed no signs of deterioration. A one year radiographic follow up showed good periapical healing (Fig 4). The restoration of the adjacent tooth was done using a three unit fixed partial denture after six months using the stabilized tooth as an abutment.

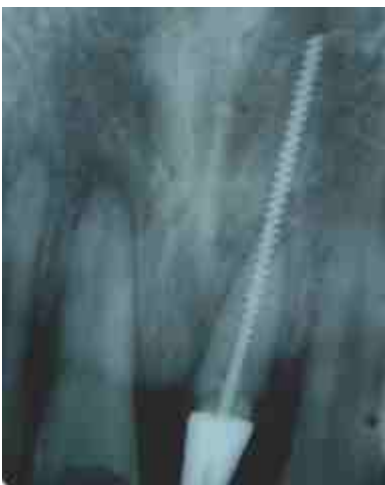
Figure 7. Immediate post operative radiograph

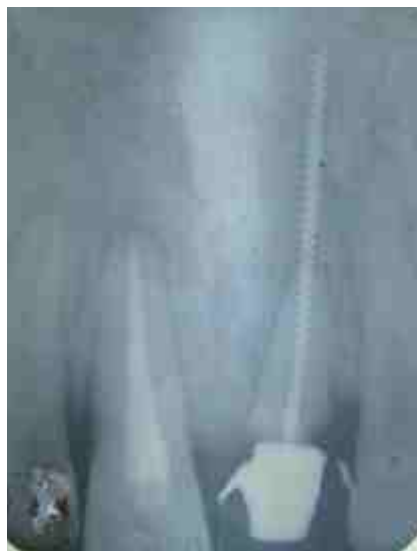
Figure 9. 8-month follow-up radiograph.

Recall examinations were conducted at periodic intervals for 8 months with continued normal findings. At the follow up appointment after two weeks a heat cure acrylic temporary crown was cemented. At 8 months the examination indicated that the tooth was well stabilized and asymptomatic, which was verified by a periapical radiograph which showed good periapical healing and a normal periradicular picture (Fig 9).

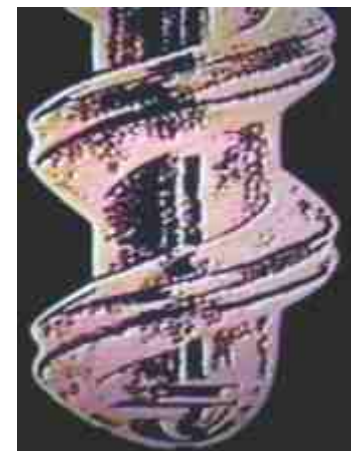
Figure 10. Serrated design of endodontic endosseous implant.

In the new design of the stabilizer used (Fig 10) the implant consists of a major diameter and a minor diameter. The drill corresponds to minor diameter so that when the implant is tapped into place the apical dentin and bone get firmly engaged onto the flutes leaving minimal gap and thus obtaining a perfect apical seal.

An additional feature is the groove running on the crest of the serrations which is twofold in function. One is that within the canal it acts as a sluiceway for escape of the endodontic sealing material in an occlusal direction as the implant is tapped apically hence preventing the apical extrusion of any cement. Secondly within the bone it helps in better stress distribution by attaching to the periimplant ligament fibers. The titanium alloy allows better osseointegration as it has been proved to have a good osteogenic effect.
